**INTEGRAL**  
**Mission Report**  
**INT-MOC-SYS-RP-1001-TOS-OF**  
**No. 013**  
**Week 51**  
**20.12.02**  
**PV Phase**

Prepared by: M. Schmidt (TOS-OGI)

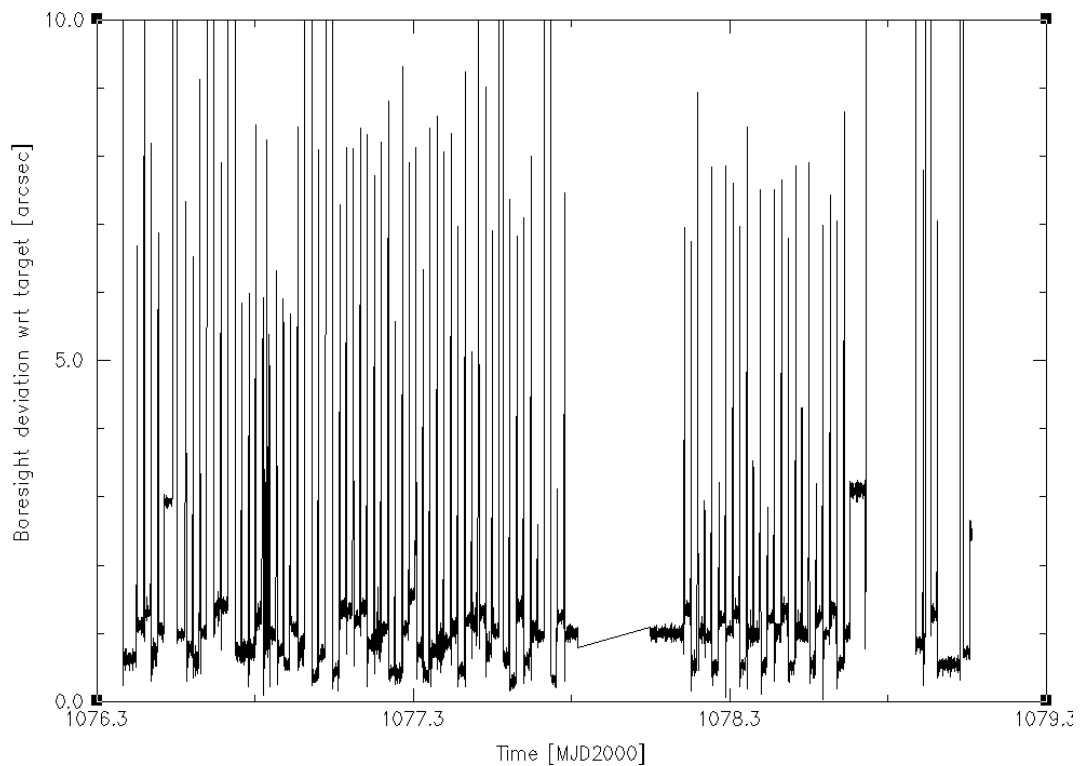
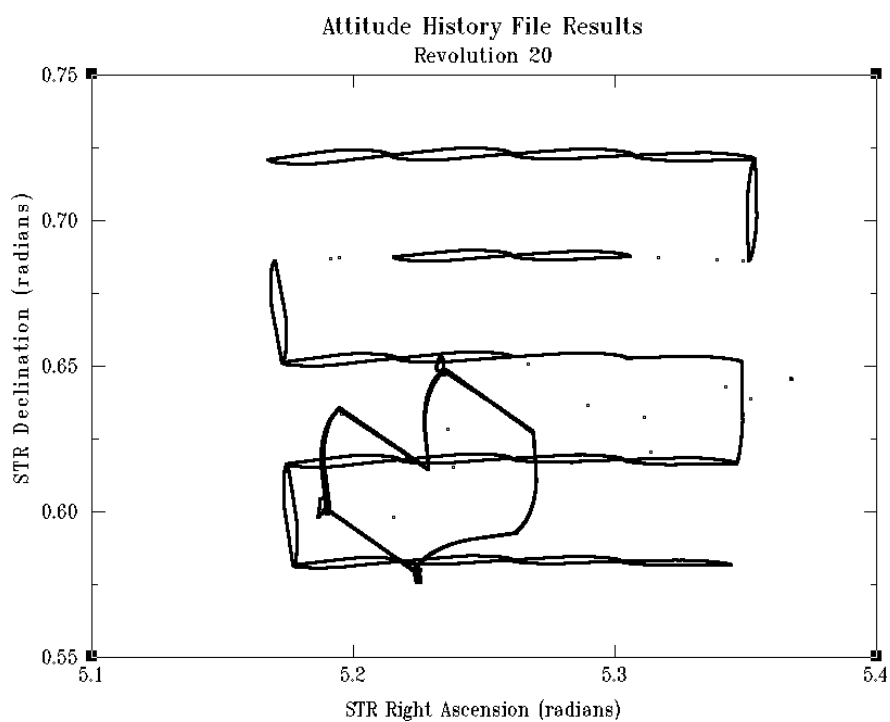
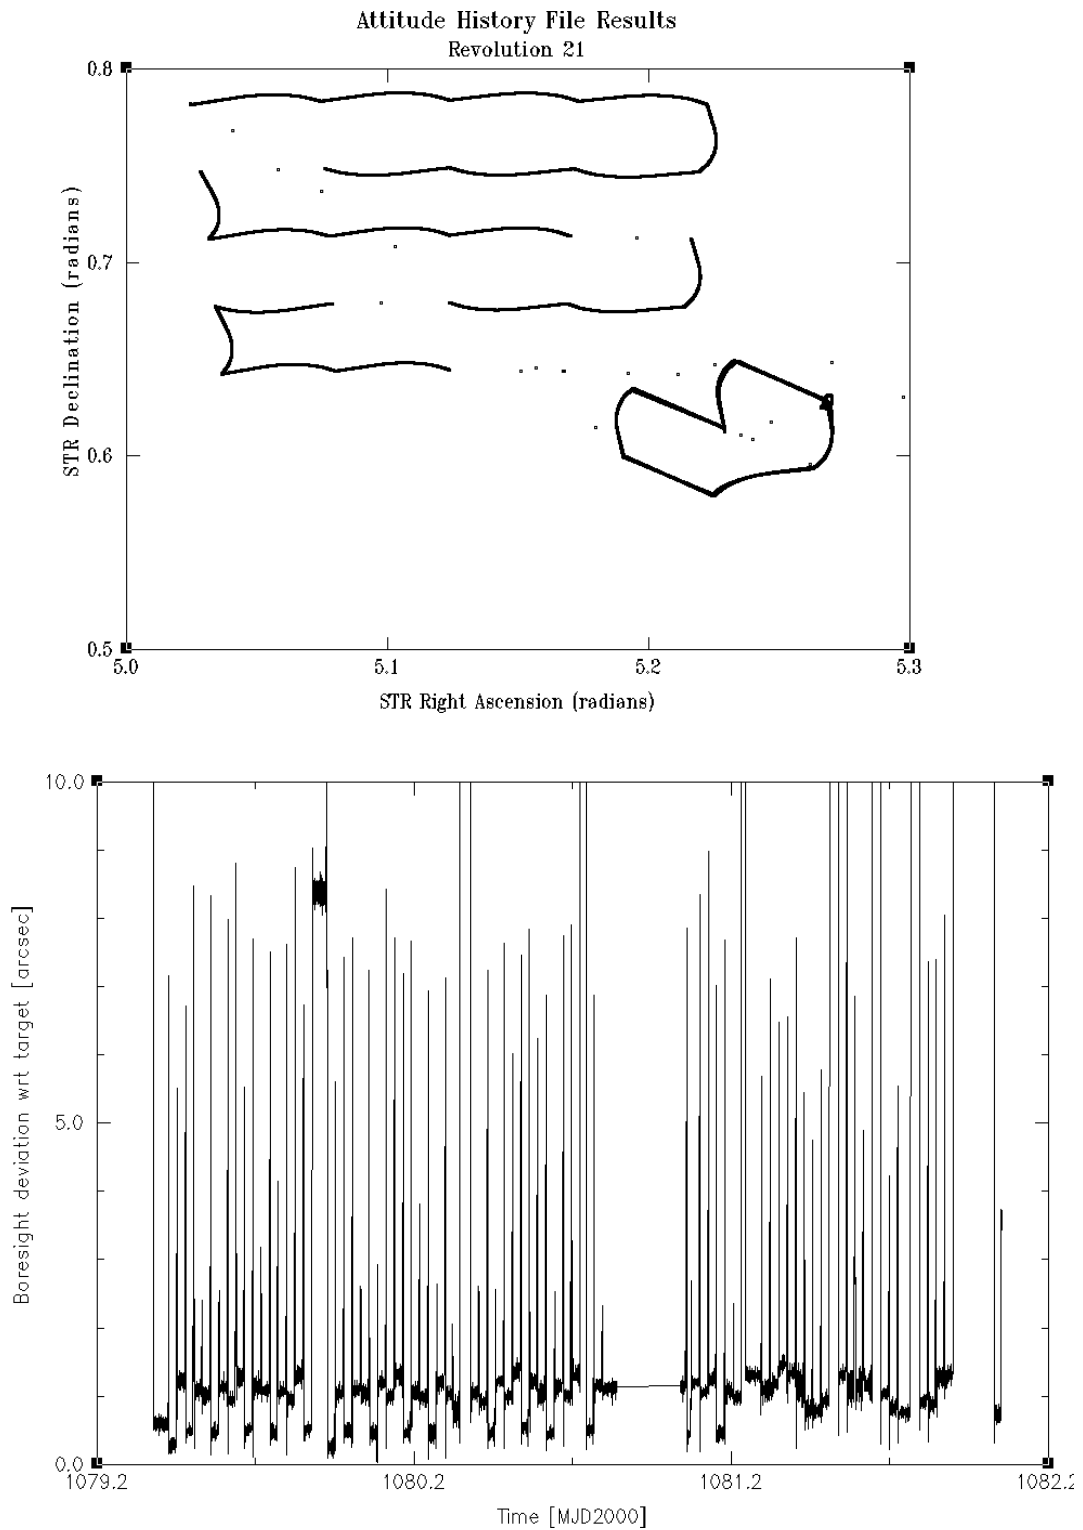
Flight Dynamics have analysed revolutions 20 and 21 of attitude history file data and conclude that the pointing accuracy for Integral during dithering and rastering is quite good (less than 2 arcsec deviation of STR boresight w.r.t. the planned target).

Here are some plots to visualise these results. Actual path of STR boresight (R.A vrs Dec) and the boresight errors w.r.t. target

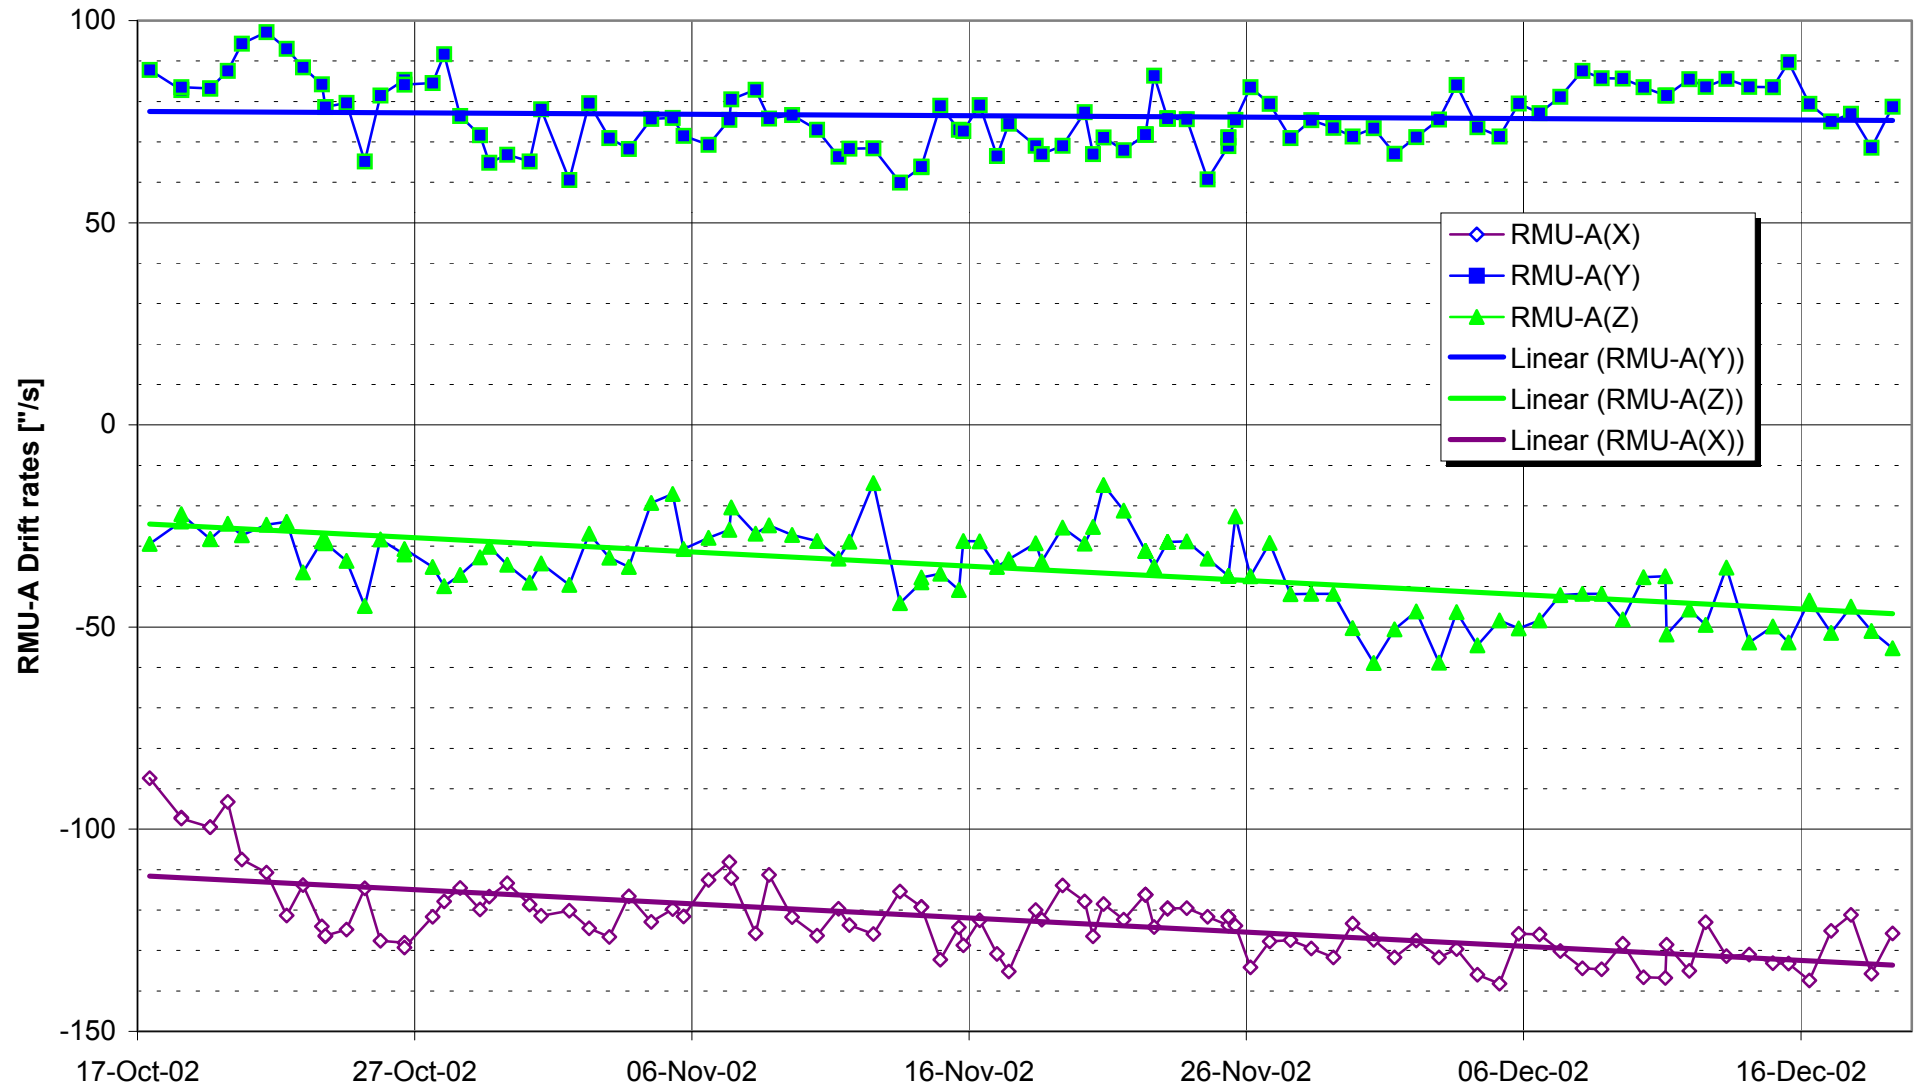
### INTEGRAL RMU Drift Calibration History

The RMU drift calibration data that have been recorded over the past 2 months have been analysed.

The soft limits are redesigned such that we do not expect a violation during the next 2 months. The situation shall be re-assessed in February 2003.

The hard limits are wider by +/- 30 "/s w.r.t. the soft limits. If the hard limits are violated, the TPF is not generated.
