**INTEGRAL**  
**Mission Report**  
**INT-MOC-SYS-RP-1001-TOS-OF**  
**No. 037**  
**Week 23**  
**10.06.03**  
**Routine Phase**

Prepared by: M. Schmidt (TOS-OFI)

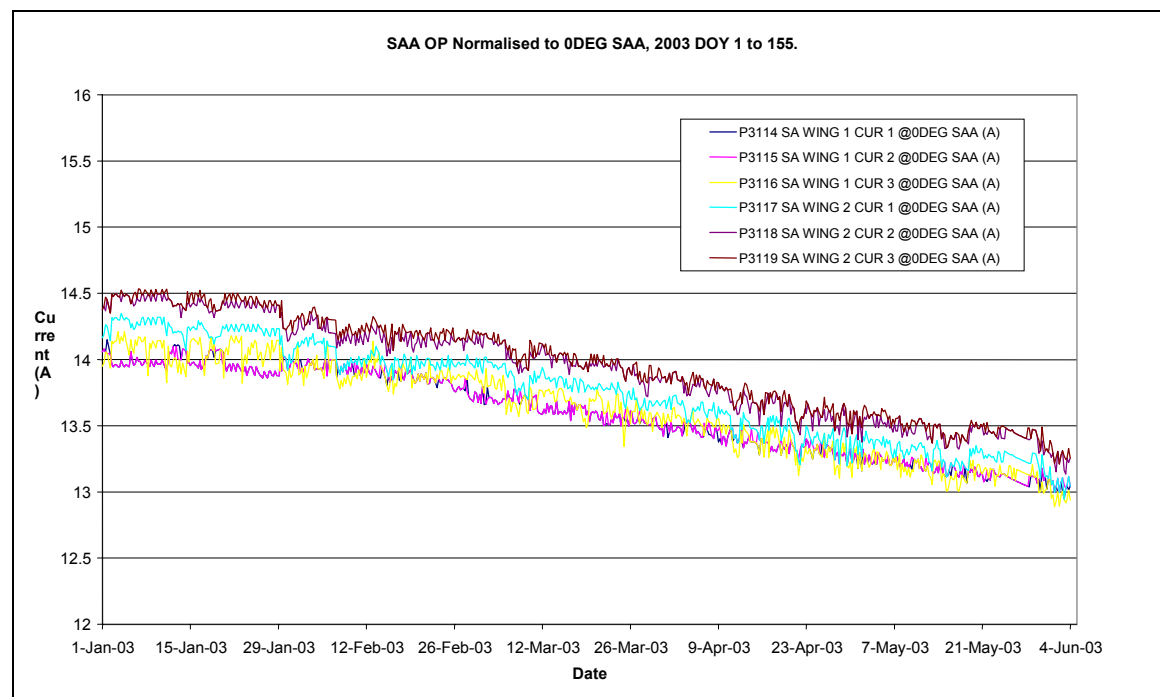
The available power from the arrays is in the order of 2230W, this compares with a figure of about 2380W in January, the reduction of about 9% is almost wholly due to seasonal variations, there is no evidence of significant degradation in array performance. A better estimate of any degradation can be made in October when Integral has been one year in Orbit.

The plot below shows the evolution of the solar array currents since the beginning of 2003.

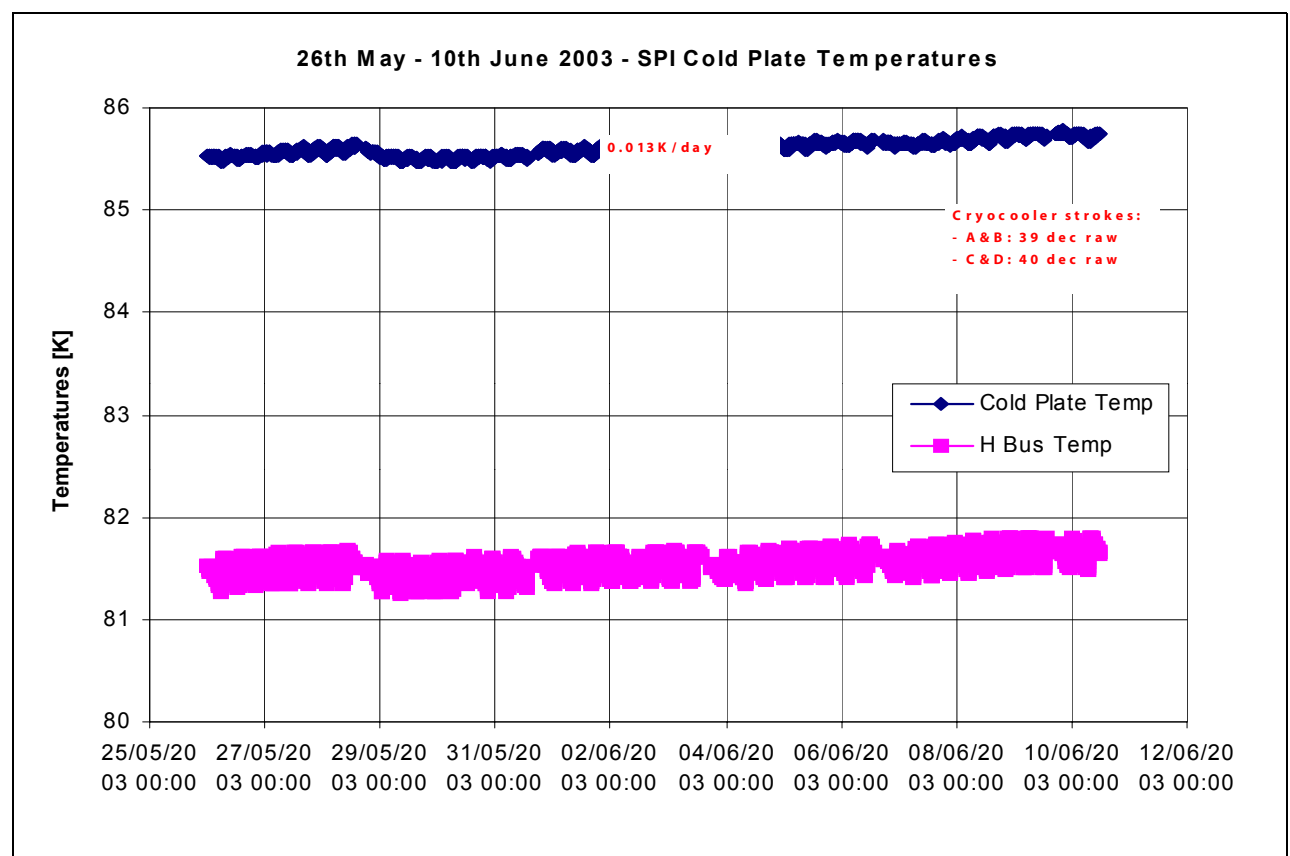
The performance of the 4 compressors is nominal and the cold plate temperature is maintained at around 85.6K. The drift phenomenon has been analyzed for the last 2 weeks and some fluctuations have been noticed: analysis of any relation with S/C attitude is on-going.

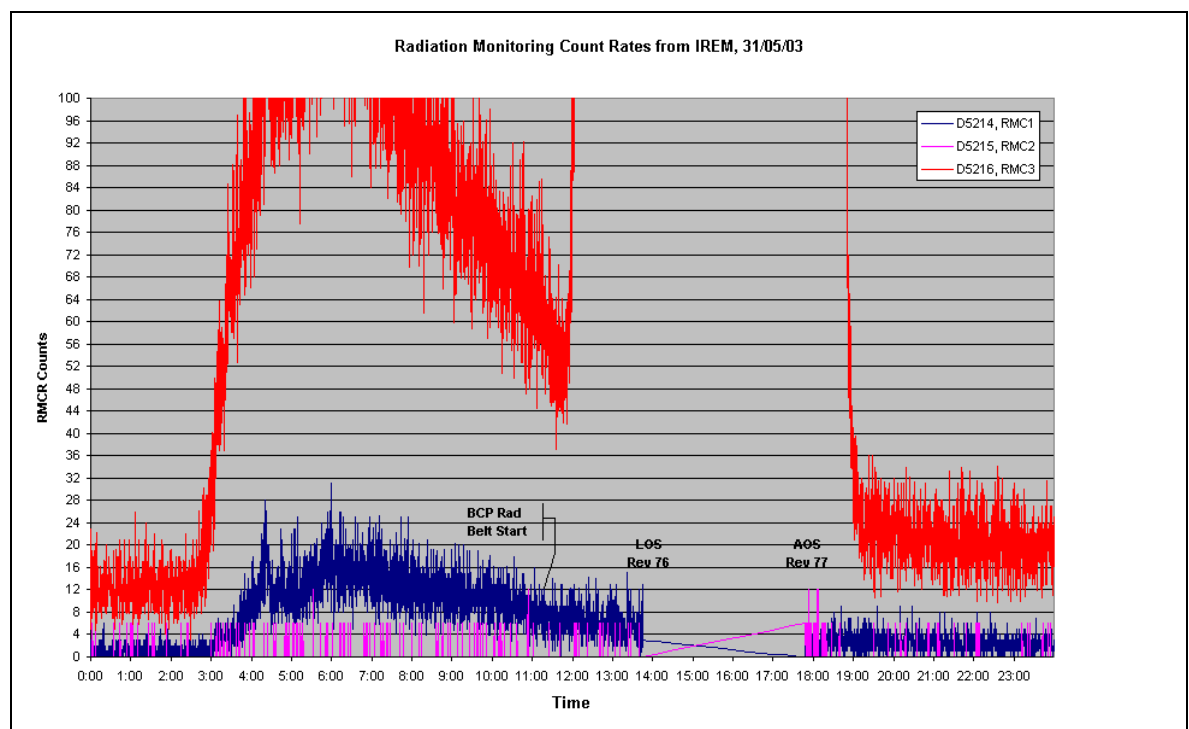
On 28/05/03 we had received "Potential Satellite Anomaly Alert" for the period from 28 to 31 May due to high solar activity. The following plot shows the IREM readings during the 31<sup>st</sup> of May. See also the INTEGRAL Weekly Report Nr.36, for week 22.

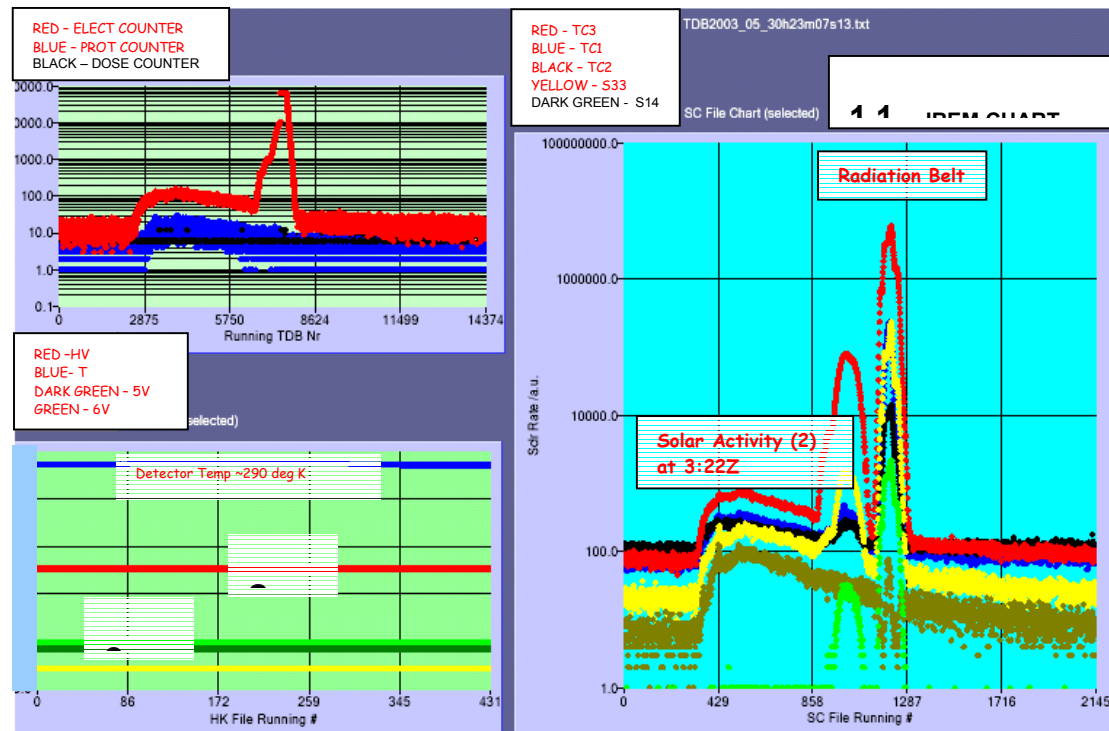
At 02.21Z reported high radiation count rates, the values reached were out of the new thresholds set for JEM-X and OMC . The high radiation environment was mainly dominated by electrons with a clear presence of protons. The plots of the IREM counters plus the accumulated SCI files are reported below.

As effect of the high count rates JEM-X and OMC were forced in Safe Mode.  
 No effects on the IREM unit have been noticed during high radiation condition.
